# ***CHENEY SCHOOL BUILDING & BENNET ACADEMY***

## **PHASE I STUDY - APRIL 17, 2013**

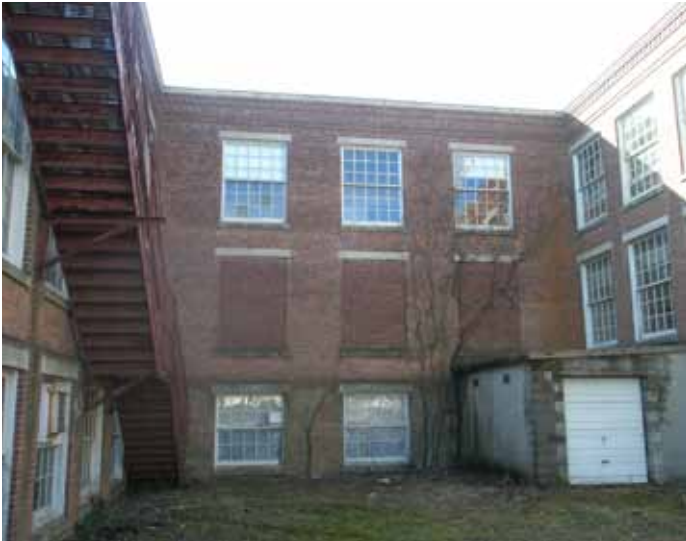
Generally speaking the brick exterior is in good condition. There appears to be no brick spalling or deterioration of the mortar. There are some vines along the north wall of the courtyard that will need to be removed and a fire escape on the east wall of the courtyard that is badly rusted and needs to be removed/replaced.

North Wall of Courtyard - Cheney Building

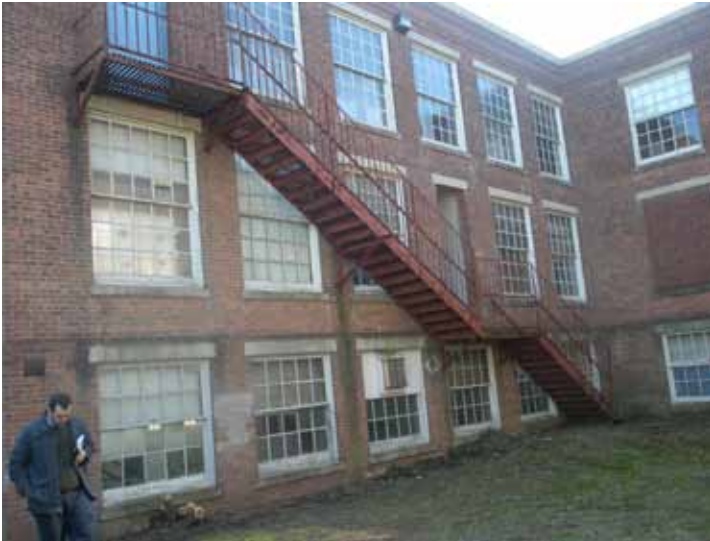
East Wall of Courtyard - Cheney Building

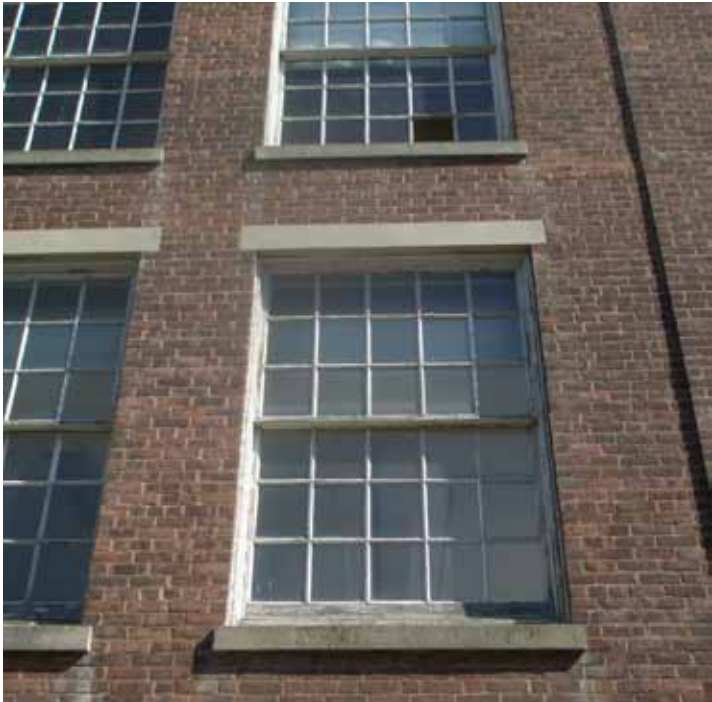
The limestone lintels and sills are in good condition but soiled. All exterior masonry should be cleaned and limited repointing should be anticipated. Windows are in poor condition with peeling paint, broken glass panes and generally no longer operable. They will require replacement. The lower level window screens are badly corroded and also need to be removed/replaced. The roofing appears to be in satisfactory shape, but roof accessories, e.g. vents, roof hatch, etc, are in poor condition.

Limestone Lintels and Sills - Good Condition but Soiled

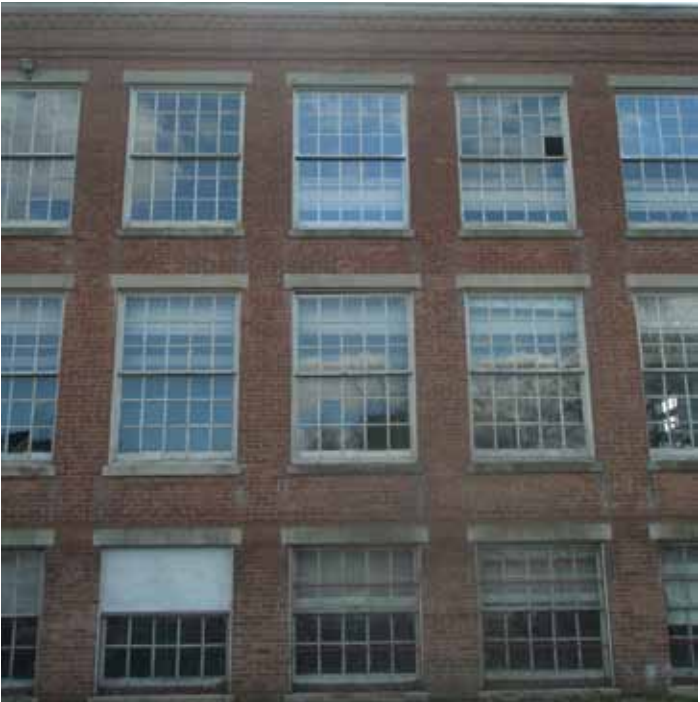
Inoperable Windows

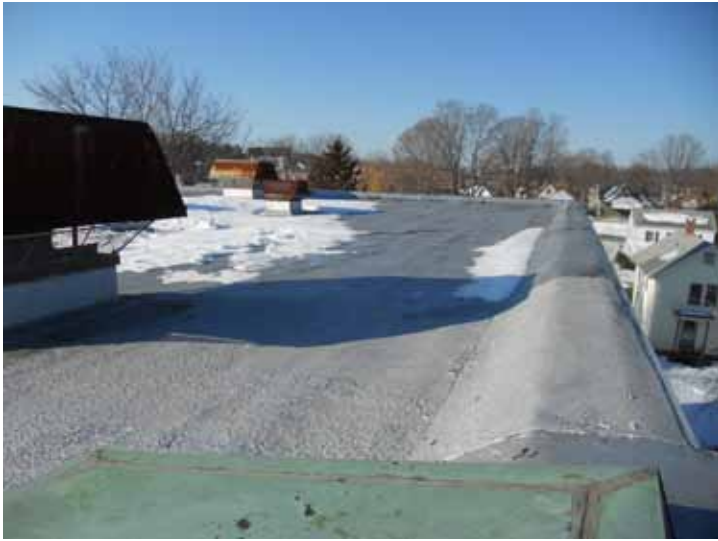
Satisfactory Roof Condition / Poor Roof Accessories Condition

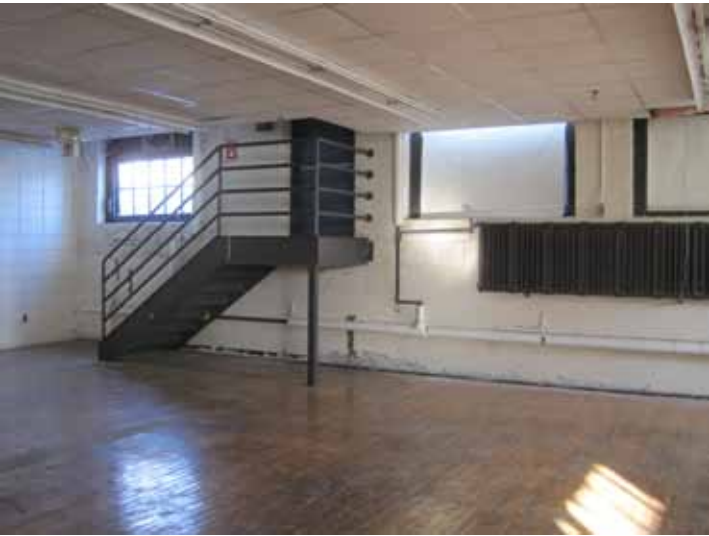
In the lower level, paint is peeling on most of the exterior walls and the wood floor is severely buckled. This is the result of moisture intrusion either through the walls or floor or both. Walls and floors need to be sealed to eliminate water intrusion and all loose paint needs to be removed.

Paint Peeling on Interior Walls

All finishes are in poor condition and should be replaced.

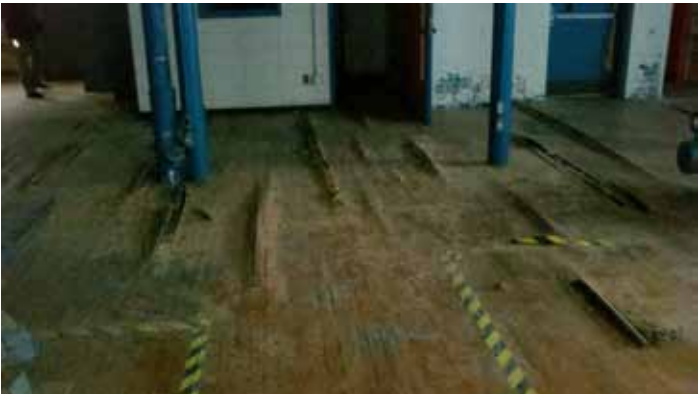
Buckled Wood Floor

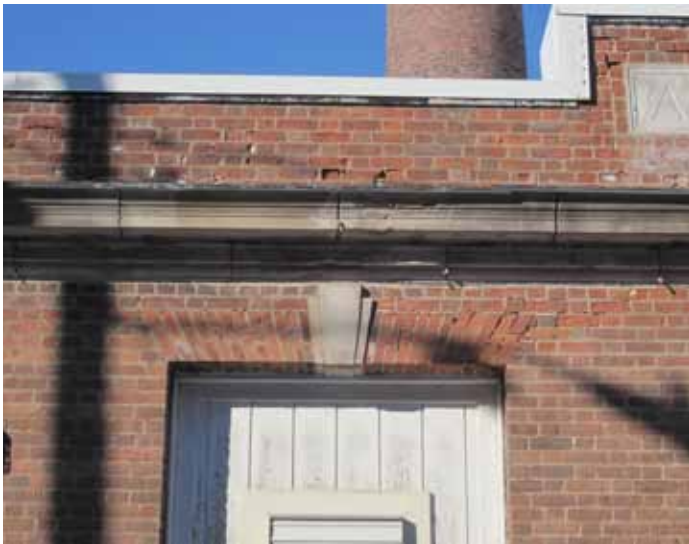
The existing masonry envelope is in fair condition with areas of spalled brick, deteriorated mortar joints, and weathered stone trim. It appears that water had been entering the walls through the stone coping and causing deterioration. At some point, the stone copings were covered with sheet metal caps to correct this problem. This appears to have stabilized the exterior and prevent further deterioration. Spalled brick should be replaced and deteriorated mortar joints repointed.

Spalled Brick, Deteriorated Mortar Joints, and Weathered Stone Trim

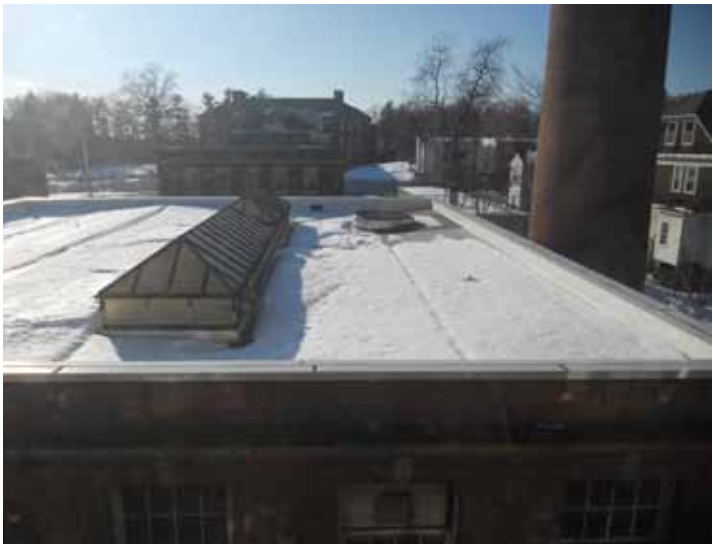
The low slope metal panel roof system is an unusual assembly that appears intact but has limited life expectancy. The large skylight assembly, is un-insulated and in fair condition.

Low Slope Metal Panel Roof System

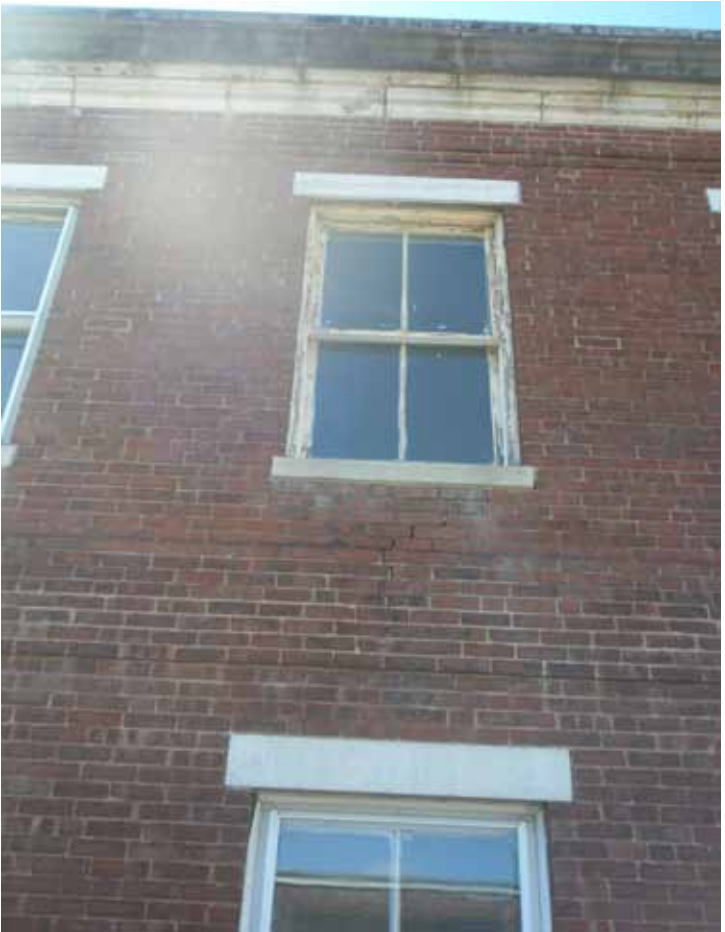
The existing masonry envelope is in fair condition with areas of cracked, deteriorated mortar joints, and weathered stone trim. Windows are peeling paint and showing signs of deterioration. Masonry cracks need to be repaired and the exterior cleaned.

Cracked, Deteriorated Mortar Joints & Weathered Stone Trim
