# ***CHENEY SCHOOL BUILDING & BENNET ACADEMY***

## **PHASE I STUDY - APRIL 17, 2013**

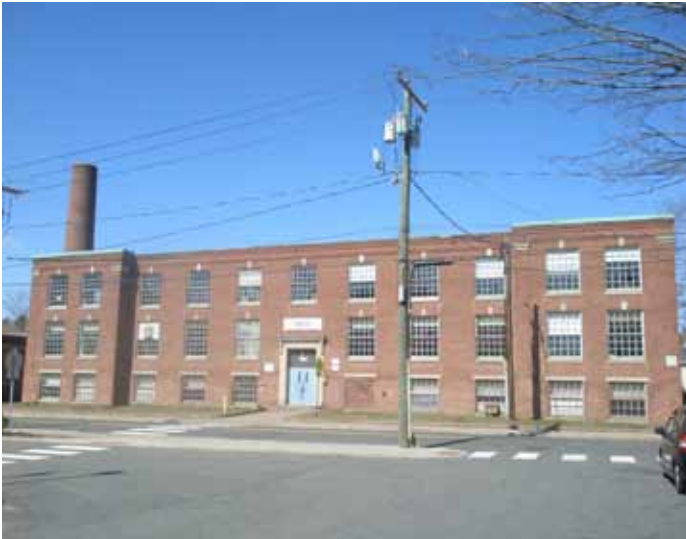
3-story Brick Structure with Limestone Trim and Built-up Asphalt Roofing

Generally speaking the brick exterior is in good condition. There appears to be no brick spalling or deterioration of the mortar. There are some vines along the north wall of the courtyard that will need to be removed and a fire escape on the east wall of the courtyard that is badly rusted and needs to be removed/replaced.

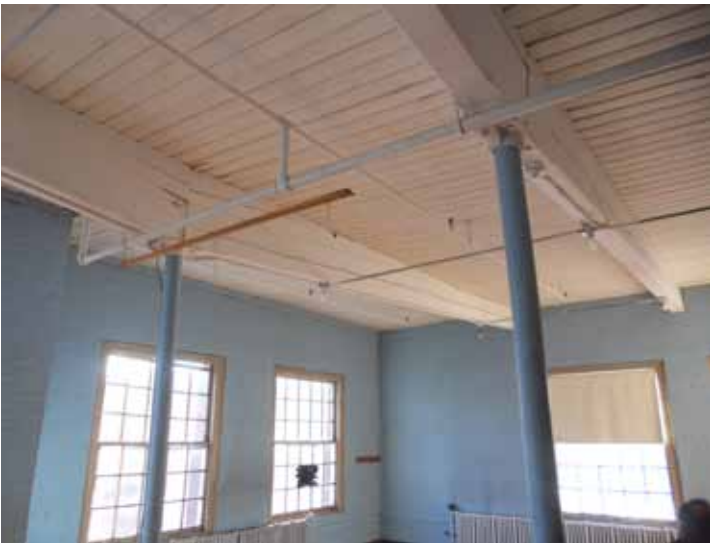
Ceiling with 2x4 acoustic tile with exposed painted structure

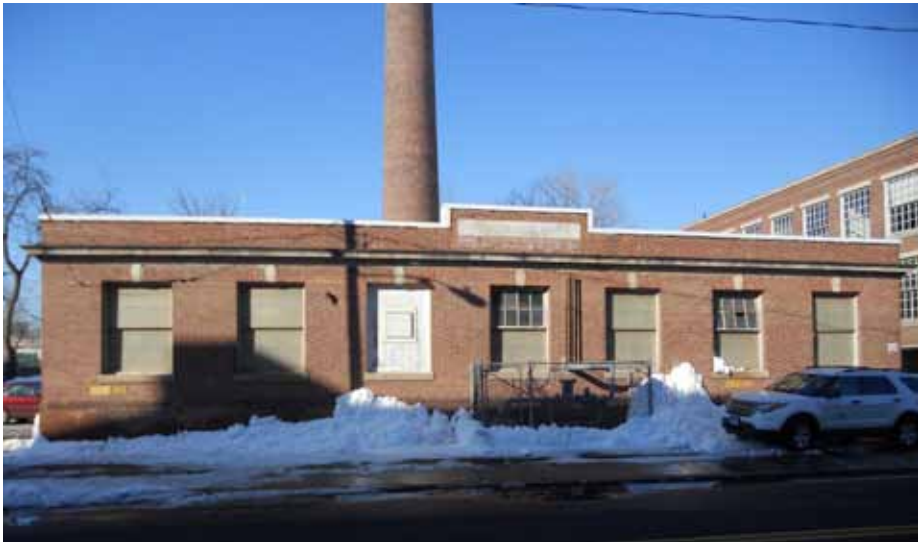
Boiler House Exterior

The existing masonry envelope is in fair condition with areas of spalled brick, deteriorated mortar joints, and weathered stone trim. It appears that water had been entering the walls through the stone coping and causing deterioration. At some point, the stone copings were covered with sheet metal caps to correct this problem. This appears to have stabilized the exterior and prevent further deterioration. Spalled brick should be replaced and deteriorated mortar joints repointed.

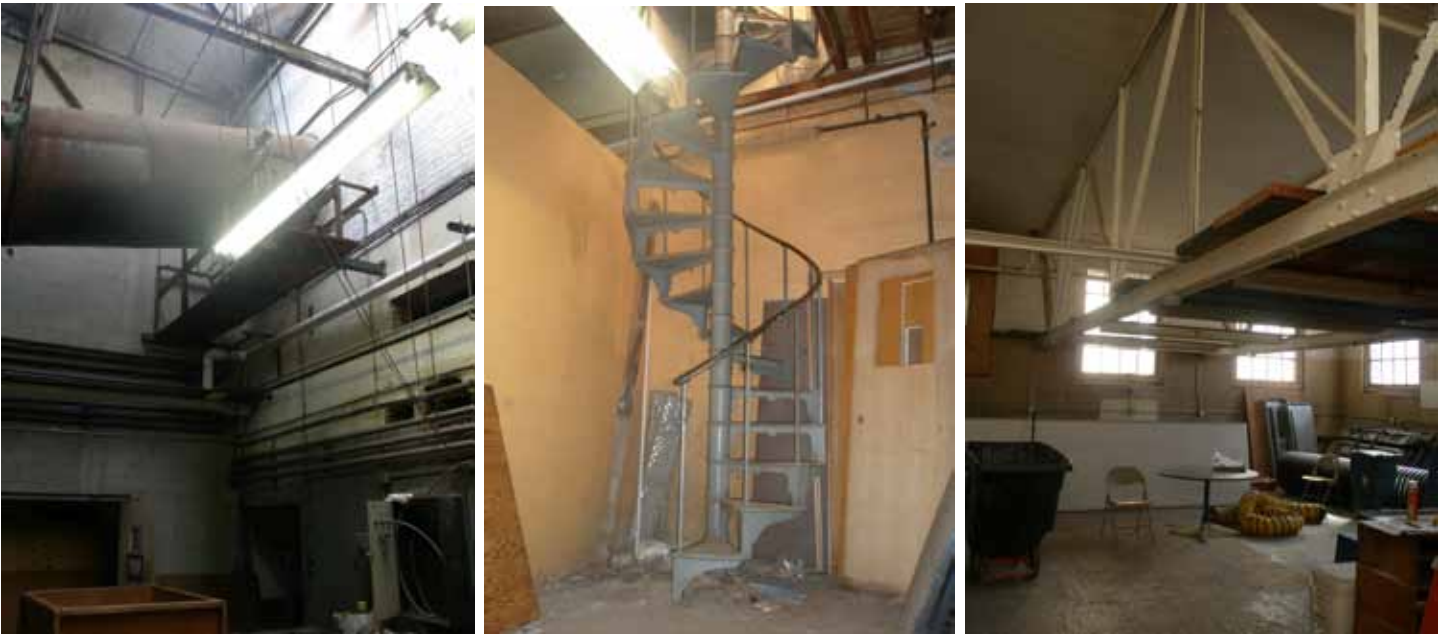
The interior of the boiler building is absent interior finishes except for some paint of exposed structure. There is a plywood mezzanine on the west side of the building with a spiral stair that connects to the lower level.

Interior of Boiler Building is Absent of Interior Finishes

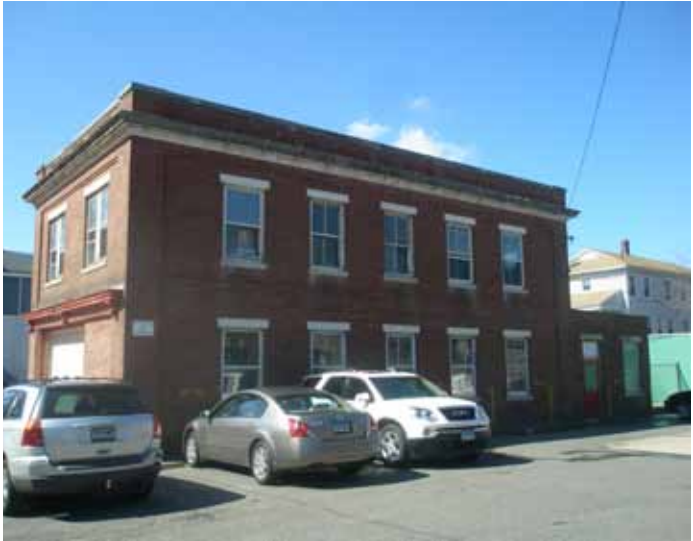
The existing masonry envelope is in fair condition with areas of cracked, deteriorated mortar joints, and weathered stone trim. Windows are peeling paint and showing signs of deterioration. Masonry cracks need to be repaired and the exterior cleaned.

2-story Brick Structure with Limestone Trim

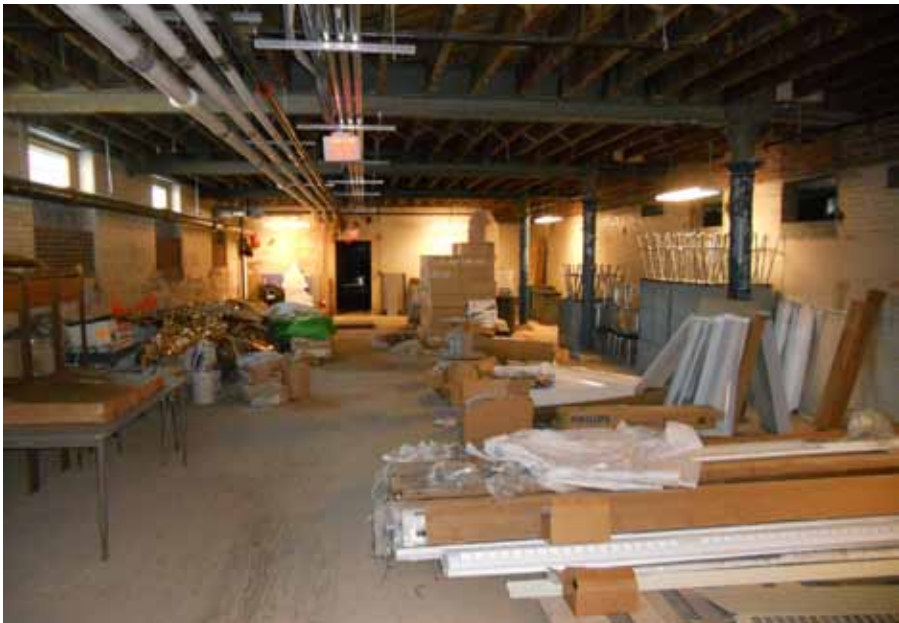
Unoccupied Space Used for Storage
